[Docket No. FAA-2015-7527; Directorate Identifier 2015-NM-094-AD; Amendment 39-18686; AD 2016-21-05]

Airworthiness Directives; The Boeing Company Airplanes

ACTION: Final rule.

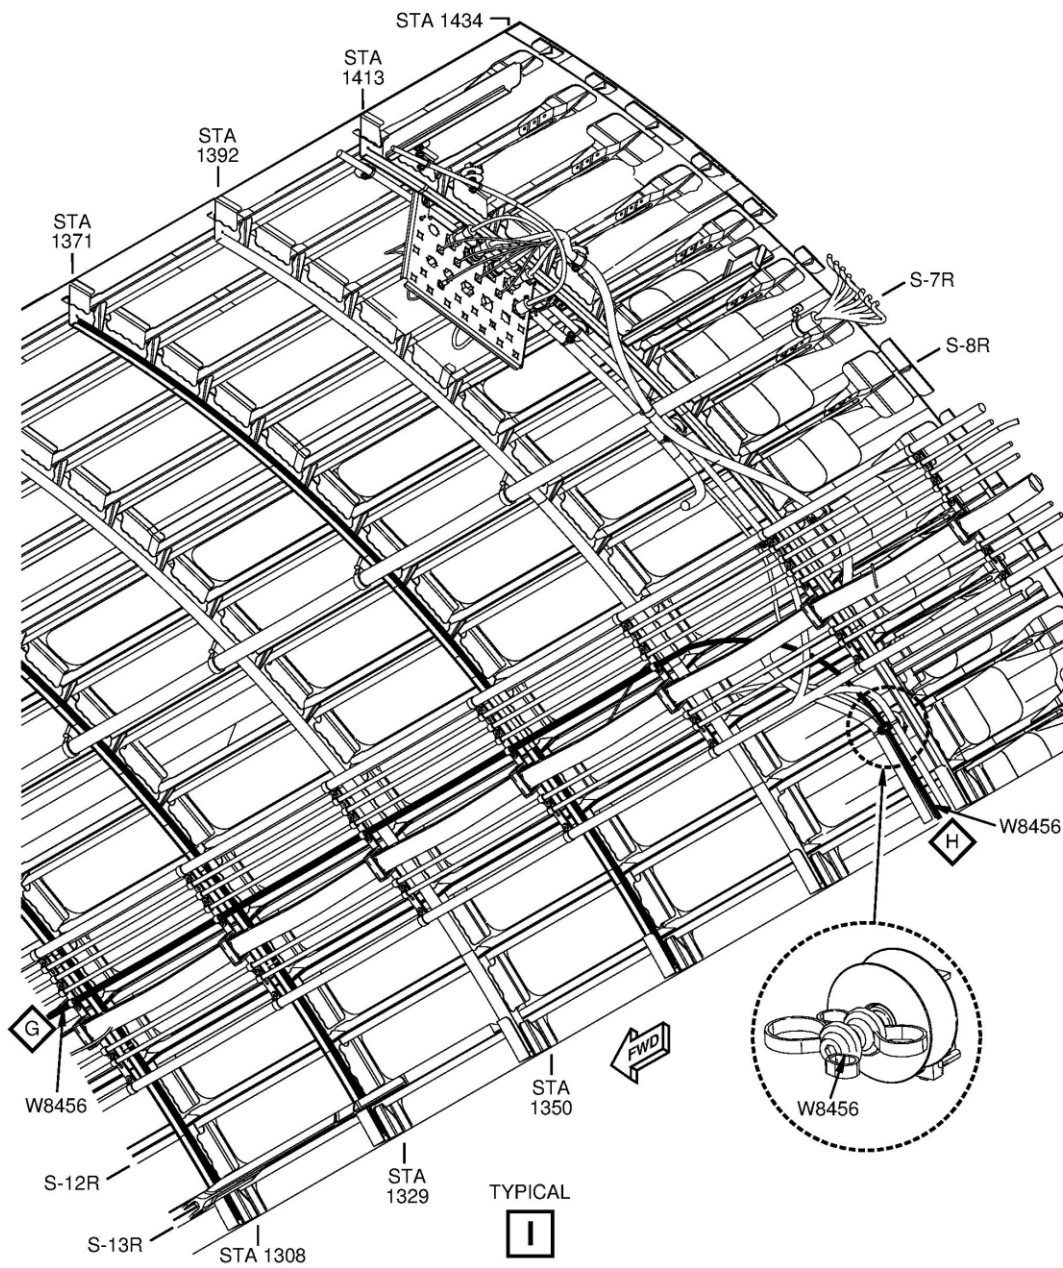
Figure 1 to paragraph (h) of this AD: Wiring Installation - Right Engine Fuel Spar Valve

an appropriate source of service information in this AD because it is not an FAA-approved document. However, we acknowledge that for certain airplanes, Figure 22, Sheet 9, of Boeing Special Attention Service Bulletin 777-28-0061, Revision 2, dated May 4, 2015, includes an editorial error, which shows incorrect wire routing. Boeing Service Bulletin Information Notice 777-28-0061, IN 03, dated November 16, 2015, allows for a modification of Group 2 airplanes that meets the requirements of the AD without an additional burden to operators. We have included a corrected figure in paragraph (h) of this AD to address this issue.

(1) Where Boeing Special Attention Service Bulletin 777-28-0061, Revision 2, dated May 4, 2015, specifies to use Figure 22, Sheet 9, for the wiring installation of the right engine fuel spar valve, this AD requires using figure 1 to paragraph (h) of this AD.
